JACKSONVILLE AVIATION AUTHORITY MARKINGS CASE STUDY

JAA Airfield Markings Case Study

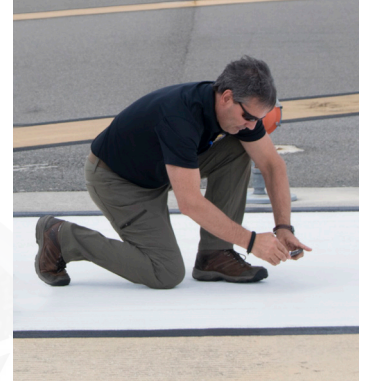
Visual Assessment

Provides visual follow-up to retroreflectivity assessment for failure cause identification and characteristics not assessed by instrument including daytime visibility, paint adhesion, bead embedment and disbursement

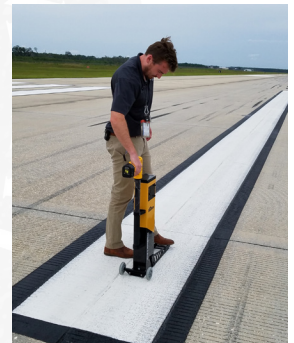
StripeMaster 2 Touch Handheld Retroreflectivity Assessment

Provides an accurate numerical assessment of markings in which utilizing a mobile unit is impractical or not efficient

Primarily for shorter lateral markings less than 250 linear feet

Used to measure
9% of runway

Used to measure
19% of taxiway

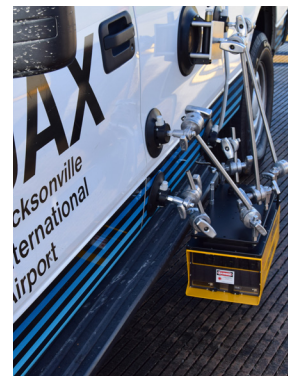
LaserLux G7 Mobile Retroreflectivity Assessment

Allows for fast and comprehensive retroreflectivity assessment which reduces time on the runway and taxiway interruption

Primarily used for longitudinal markings and longer lateral markings greater than 250 linear feet

Used to measure
91% of runway

Used to measure
81% of taxiway

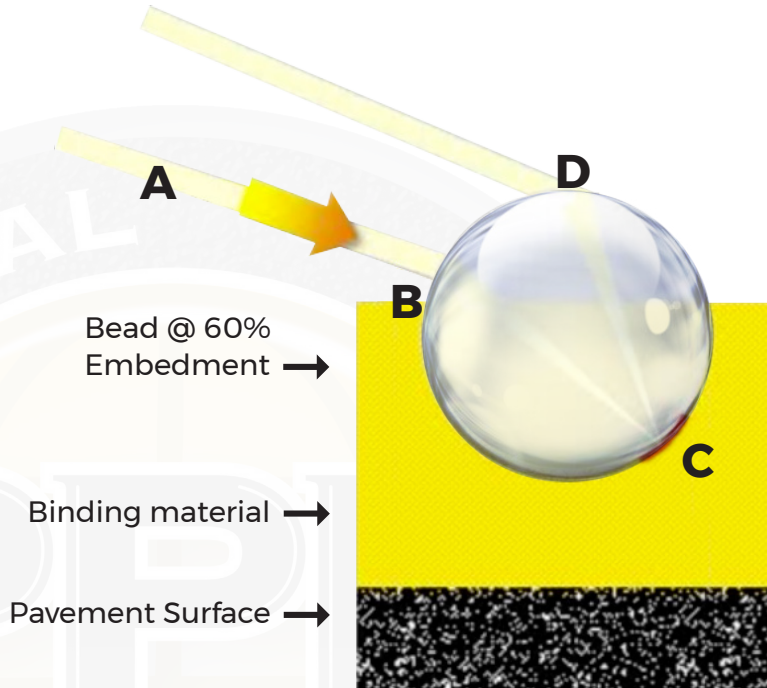
Retroreflectivity

Ability of an object (Stop sign) to redirect light back to its source (An automobile's headlights)

- A. Light comes from source
- B. Light bends (refracts) at point of entry of glass
- C. Light reflects off back of glass bead taking the binding material's color with it
- D. Light bends (refracts) again at point of exit of the glass bead

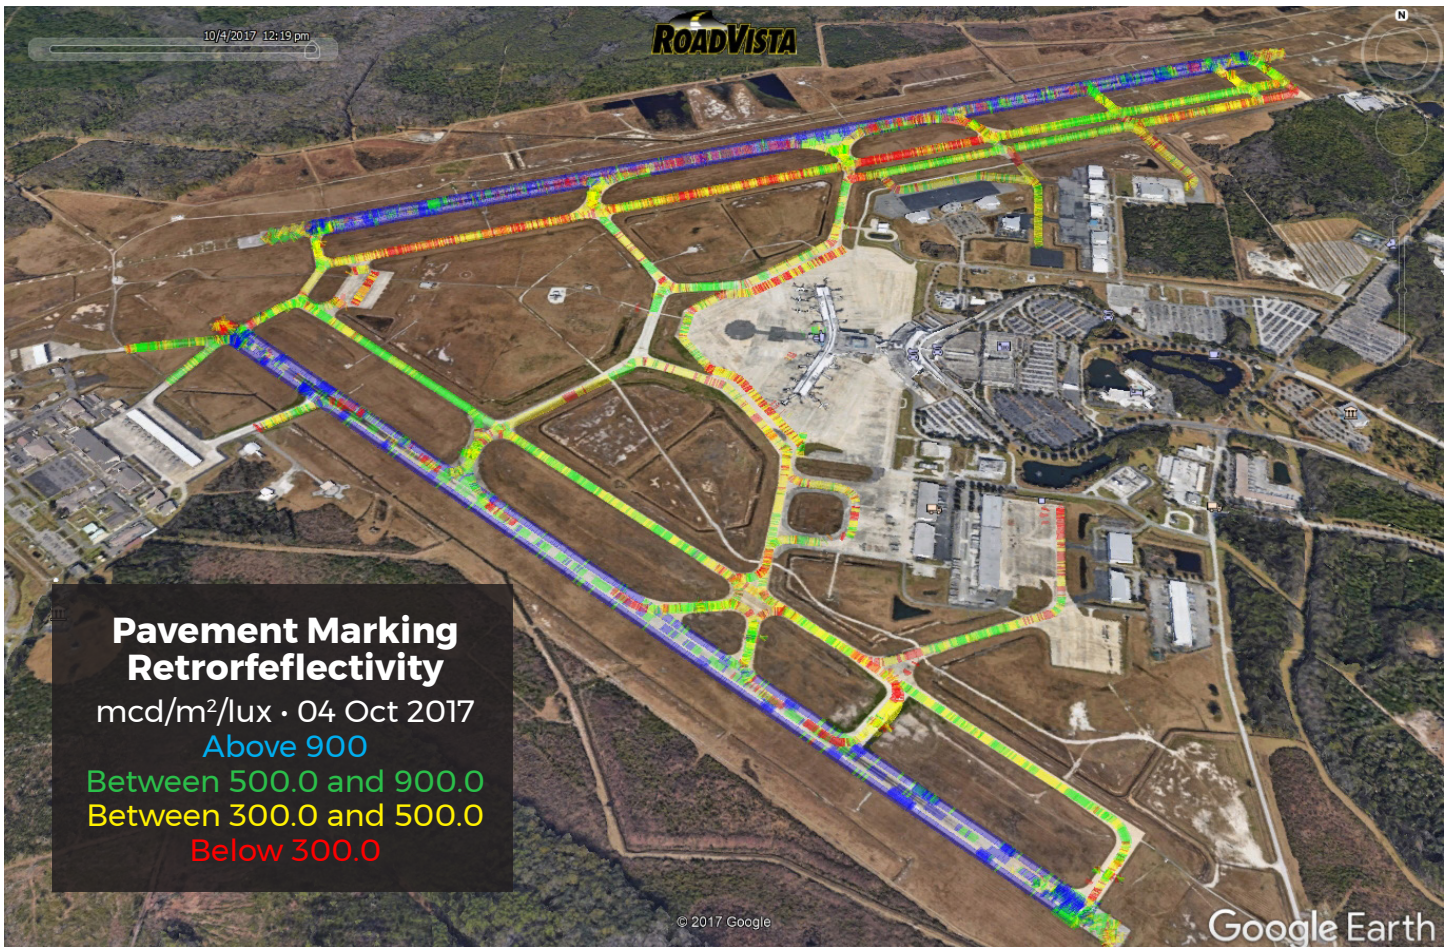
Data was recorded integrating Google Satellite Maps and assigned a color to designate retroreflectivity performance.

● Level 1	14 percent	Below preferred minimum
● Level 2	31 percent	Maintenance
● Level 3	29 percent	Good
● Level 4	25 percent	Excellent

Overall, the average reading throughout the airfield was an impressive (by roadway standards) 621 mcd/lux/m²

JAA immediately put the data from the assessment to use. The crew targeted the level 1 (below minimum) areas first and then developed a maintenance plan for the other segmented areas. The data enabled them to be more efficient with their resources and materials. The discussed action plan moving forward is having two additional full assessments; one in six months and one 12 months to establish a trend pattern. After the three initial assessments, JAA could go to an annual full assessment with interim assessment utilizing the handheld SM2T. The data from the trends study will assist JAA in saving money and other resources while ensuring and improving overall airfield safety. The interim assessments would provide for both contracted and internal marking maintenance quality assurance.

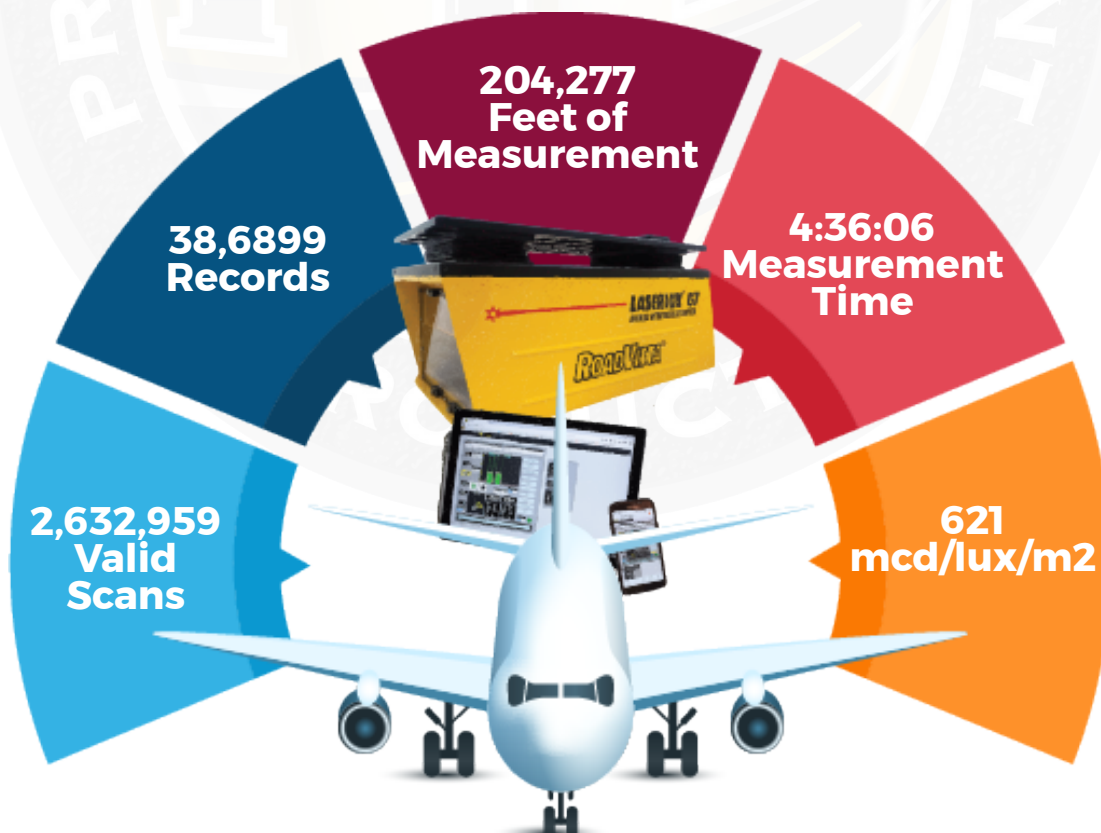
The LLG7 is equipped with advanced GPS technology that most often provides sub-meter accuracy. In such, it provides distance measured and the longitudinal/latitudinal coordinates of each calculated Record. In this case it measured nearly 39 miles of line.

The LLG7 provides a .KML file that overlays a detailed visual report on the airfield through the use of Google Earth which allows the airfield operations staff to identify sections in need of maintenance and with periodic assessment provides for trending.

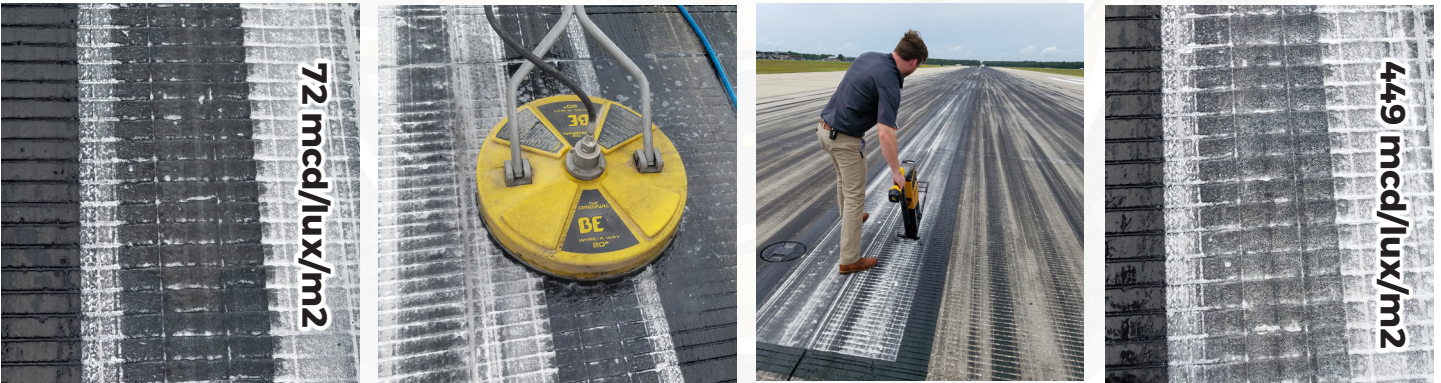
Rubber build-up and removal impact on retroreflectivity

While assessing the runway centerline with the handheld retroreflectometer, a maintenance crew was hydroblasting the markings by hand in attempt to improve their visibility and friction coefficient. The team took this opportunity to measure the effects of this process on retroreflectivity.

There were initial readings of 72 mcd/lux/m2 when a total of six passes were made over a three-foot section at 30 seconds per pass at 4,000 psi. Measurements were recorded between passes and retroreflectivity increased with each pass. After the sixth pass the measurement was 449 mcd/lux/m2. It was determined that daytime contrast visibility was only slightly improved. However, as the film of the rubber was removed for the glass surface of the beads, the coating’s pigment sealed under the bead became increasingly visible through retroreflectivity even though the visual contrast had limited improvement; demonstrating that retroreflectivity under these conditions can improve or exist when daytime contrast does not.

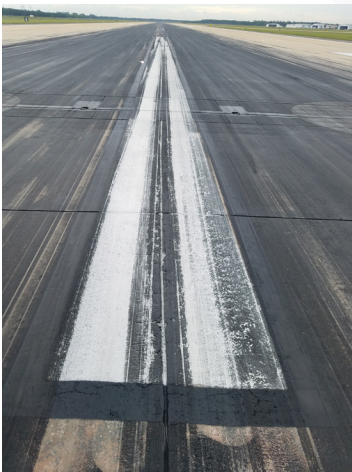
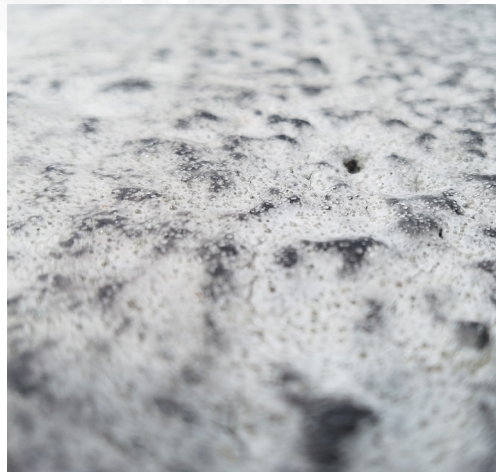
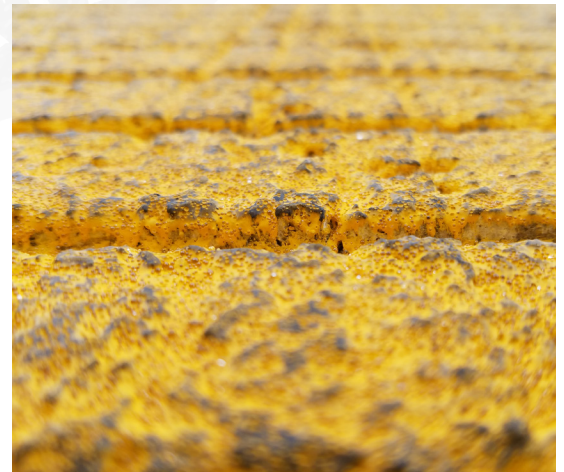
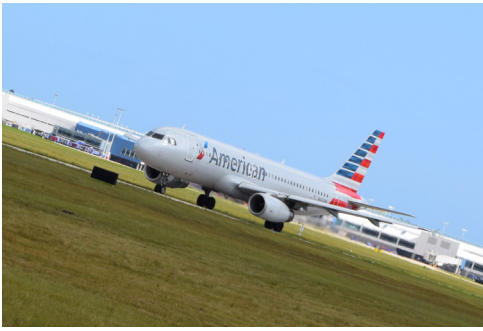
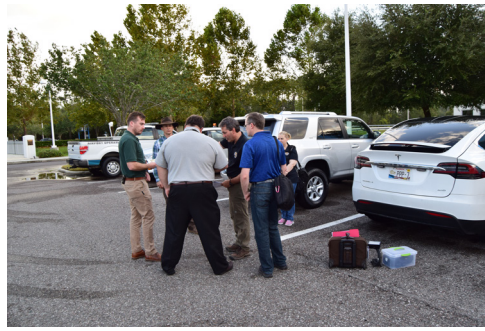
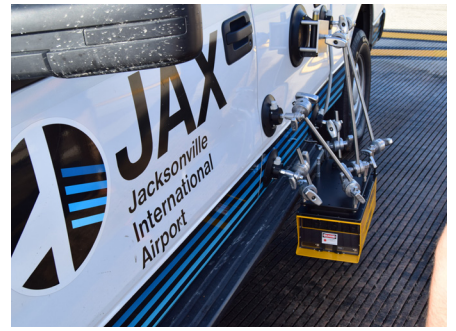
Upon the team’s visual inspection, issues with bead coverage and embedment of beads in the existing markings were discovered. Using a handheld smart phone with a camera, the team photographed the line with flash. This simple process exposed the fact that beads were concentrated in the center and very few were on the edges, thus reducing the markings’

retroreflective width. It was determined that the maintenance crew had been using a standard architectural tip when striping; a common mistake made by pavement marking professions, thus feathering the edges, reducing the paint's thickness and ability to hold beads in this area. The team also took several macro photos of the markings and the beads to investigate bead embedment. These photos exposed the fact that many of the beads had become detached and therefore, reducing the markings' retroreflectivity. It was discovered that the paint's foundational resin was not adequate for bead adhesion. Both issues were immediately corrected via a proper tip and new paint that was ordered for future applications.
