JACKSONVILLE AVIATION AUTHORITY MARKINGS CASE STUDY

UPDATED 2019

JAA Airfield Markings Case Study

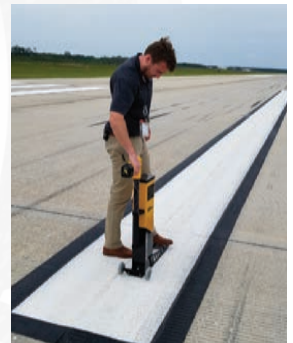
LaserLux G7 Mobile Retroreflectivity Assessment

Allows for fast and comprehensive retroreflectivity assessment which reduces time on the runway and taxiway interruption

Primarily used for longitudinal markings and longer lateral markings greater than 250 linear feet

Used to measure
91% of runway

Used to measure
81% of taxiway

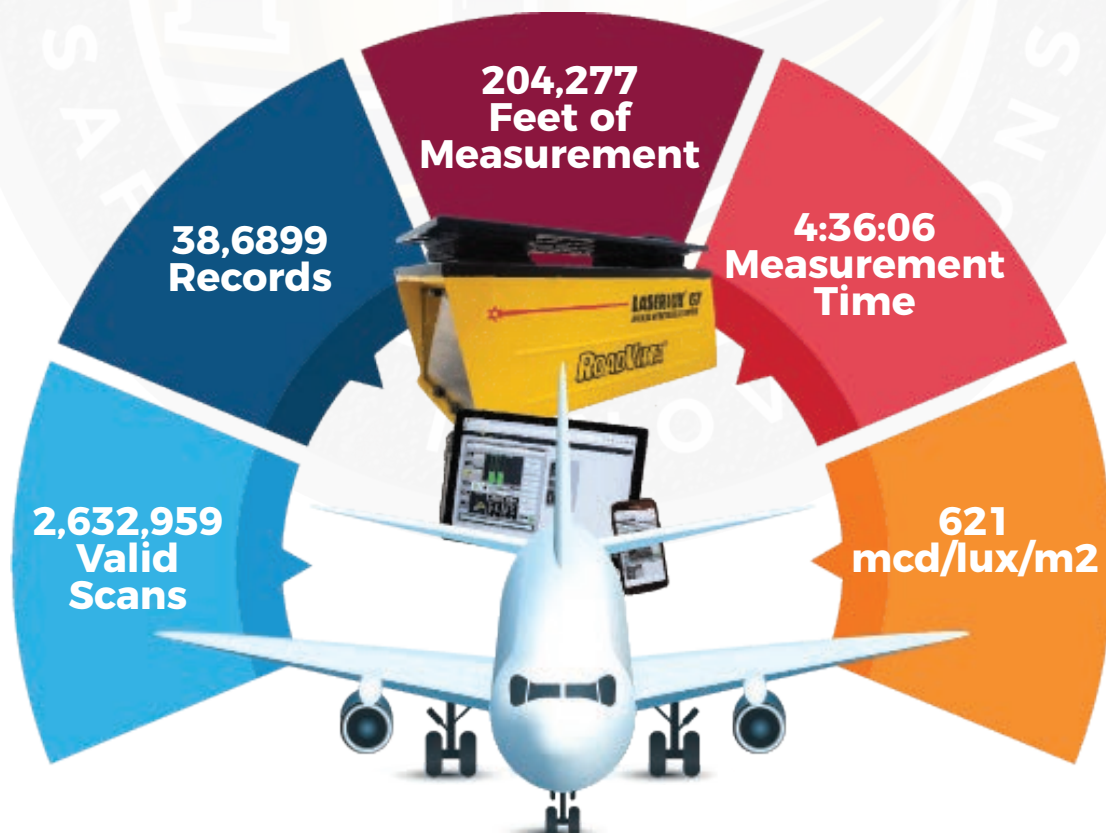
The LLG7 provides a .KML file that overlays a detailed visual report on the airfield through the use of Google Earth which allows the airfield operations staff to identify sections in need of maintenance and with periodic assessment provides for trending.

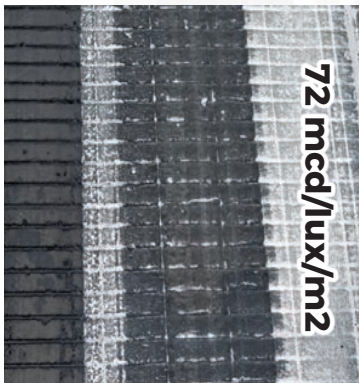
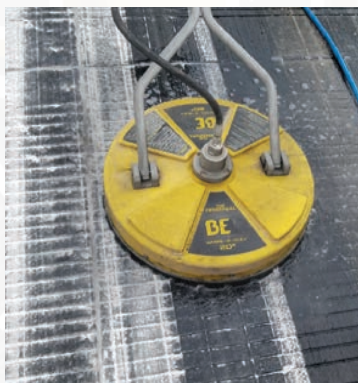
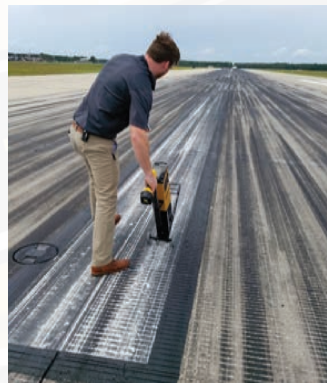
There were initial readings of 72 mcd/lux/m2 when a total of six passes were made over a three-foot section at 30 seconds per pass at 4,000 psi. Measurements were recorded between passes and retroreflectivity increased with each pass. After the sixth pass the measurement was 449 mcd/lux/m2. It was determined that daytime contrast visibility was only slightly improved. However, as the film of the rubber was removed for the glass surface of the beads, the coating's pigment sealed under the bead became increasingly visible through retroreflectivity even though the visual contrast had limited improvement; demonstrating that retroreflectivity under these conditions can improve or exist when daytime contrast does not.

While assessing the runway centerline with the handheld retroreflectometer, a maintenance crew was hydroblasting the markings by hand in attempt to improve their visibility and friction coefficient. The team took this opportunity to measure the effects of this process on retroreflectivity.
